FORD MOTOR COMPANY,

Case No. 3:17-cv-05201 RBL

REPORT OF THOMAS READ

February 22, 2019

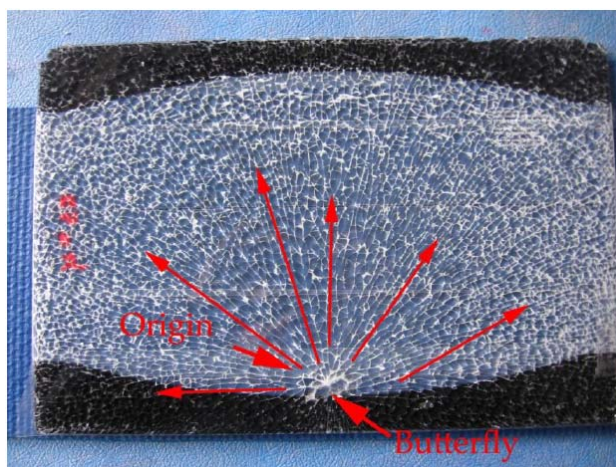
46. The following is a photograph of a tempered soda lime glass toaster oven door panel that was broken using a spring loaded center punch that created a crack that penetrated the compressive layer and caused the glass to self-destruct. This panel was covered with clear tape on the back side, to hold the pieces together, and it was then center punched at the origin. The cracking radiated from the origin, and at the origin is a tell-tale “butterfly”. The failure analysis follows the radiating cracks back to the origin; the pieces at the origin are removed to expose the fracture surface, and the origin is analyzed microscopically to determine the cause.

Figure #7: Demonstration of an overall crack pattern. The cracking radiates from the origin at a speed of 3600 MPH, and the glass panel breaks into a large number of small pieces.

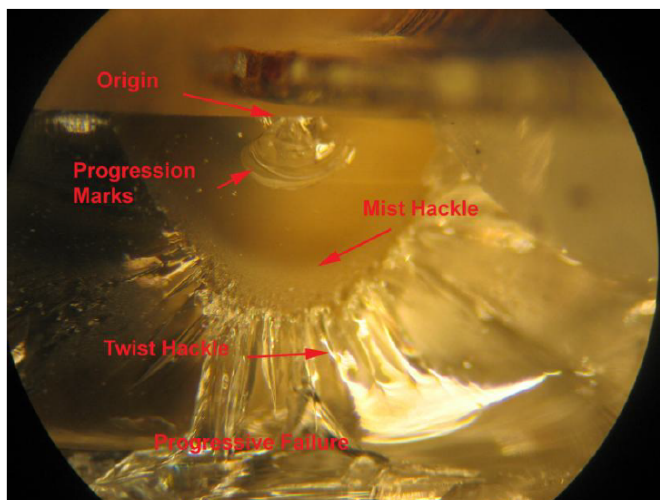
47. The following is a photograph of a tempered soda lime glass pot lid. This failure was initiated where a steel cup washer was rubbing on the underside of the tempered glass pot lid. Over time the rubbing created a progressive flaw in the glass that penetrated the outer compression layer into the tensile region and the glass cover self-destructed. This is not an impact failure.

Figure #8: Photomicrograph of a known progressive tempered glass failure.

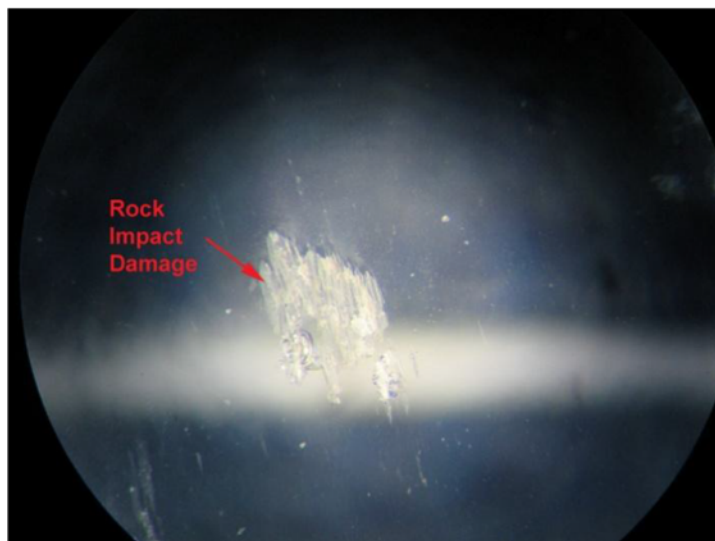
48. The following is a photograph of a fully tempered glass panel that was impacted with a rock that damaged the surface, but did not penetrate the compressive layer. Thus, it did not cause a failure.

Figure #9: A fully tempered glass panel was impacted with a rock, but the impact did not cause failure. The surface damage is abrasive in nature.

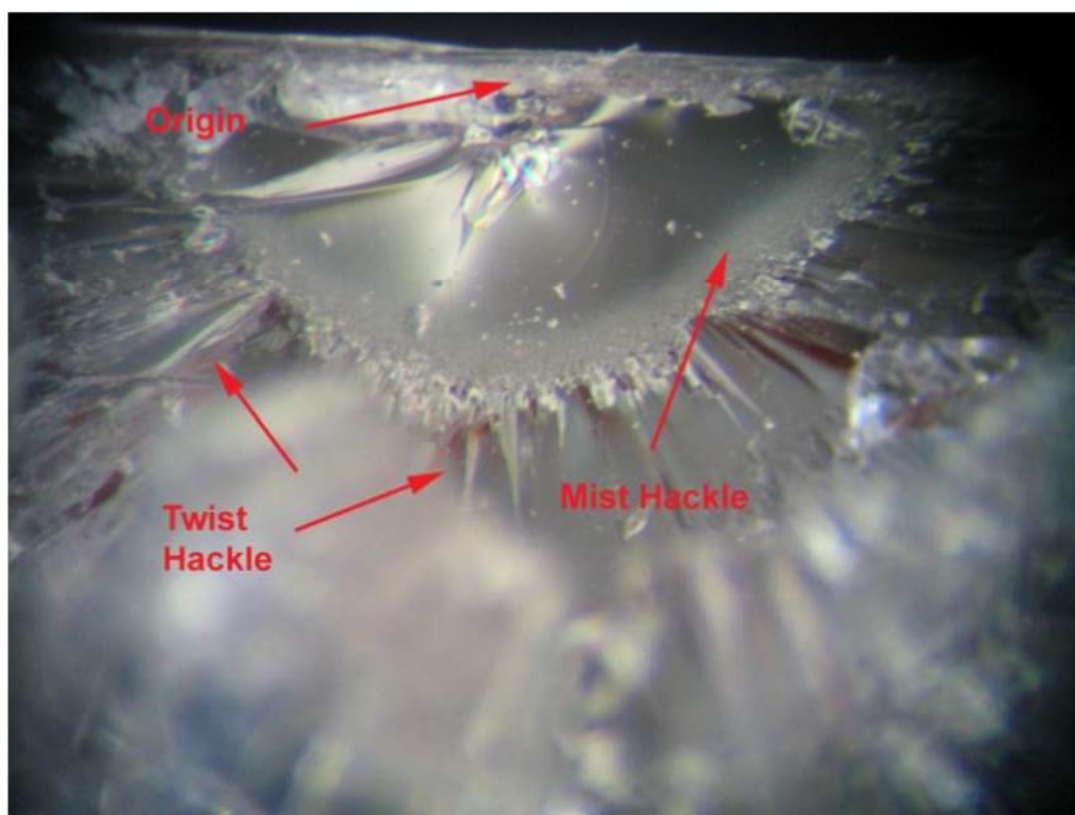
49. The following is a photograph of the glass panel in Figure #9, which was later put under bending load to failure. The failure originated at the abrasion shown in Figure #9. The origin is shown above. This failure is not progressive in nature. However, it demonstrates that post-damage stresses can drive a defect to failure.

Figure #10: The damaged panel above, also shown in Figure #9 (Mag. 40X).

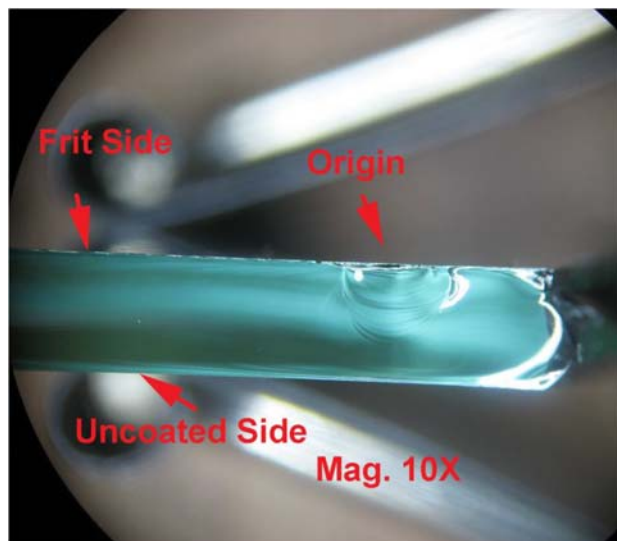
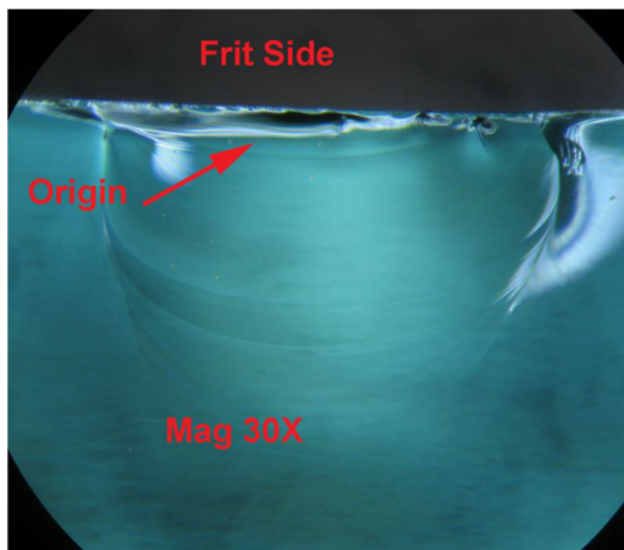
50. Figures #11 & 12 are photomicrographs, which demonstrate that the glass in contact with the frit is not fully tempered.

Figures #11 and #12: Photomicrographs above showing a failure from thermal shock that initiated under the frit in tempered glass. This glass without the frit would easily pass thermal shock testing.
